# Debris/Ice/TPS Assessment and Integrated Photographic Analysis of Shuttle Mission STS-71

*Gregory N. Katnik, Barry C. Bowen, J. Bradley Davis*

**27 June 1995**

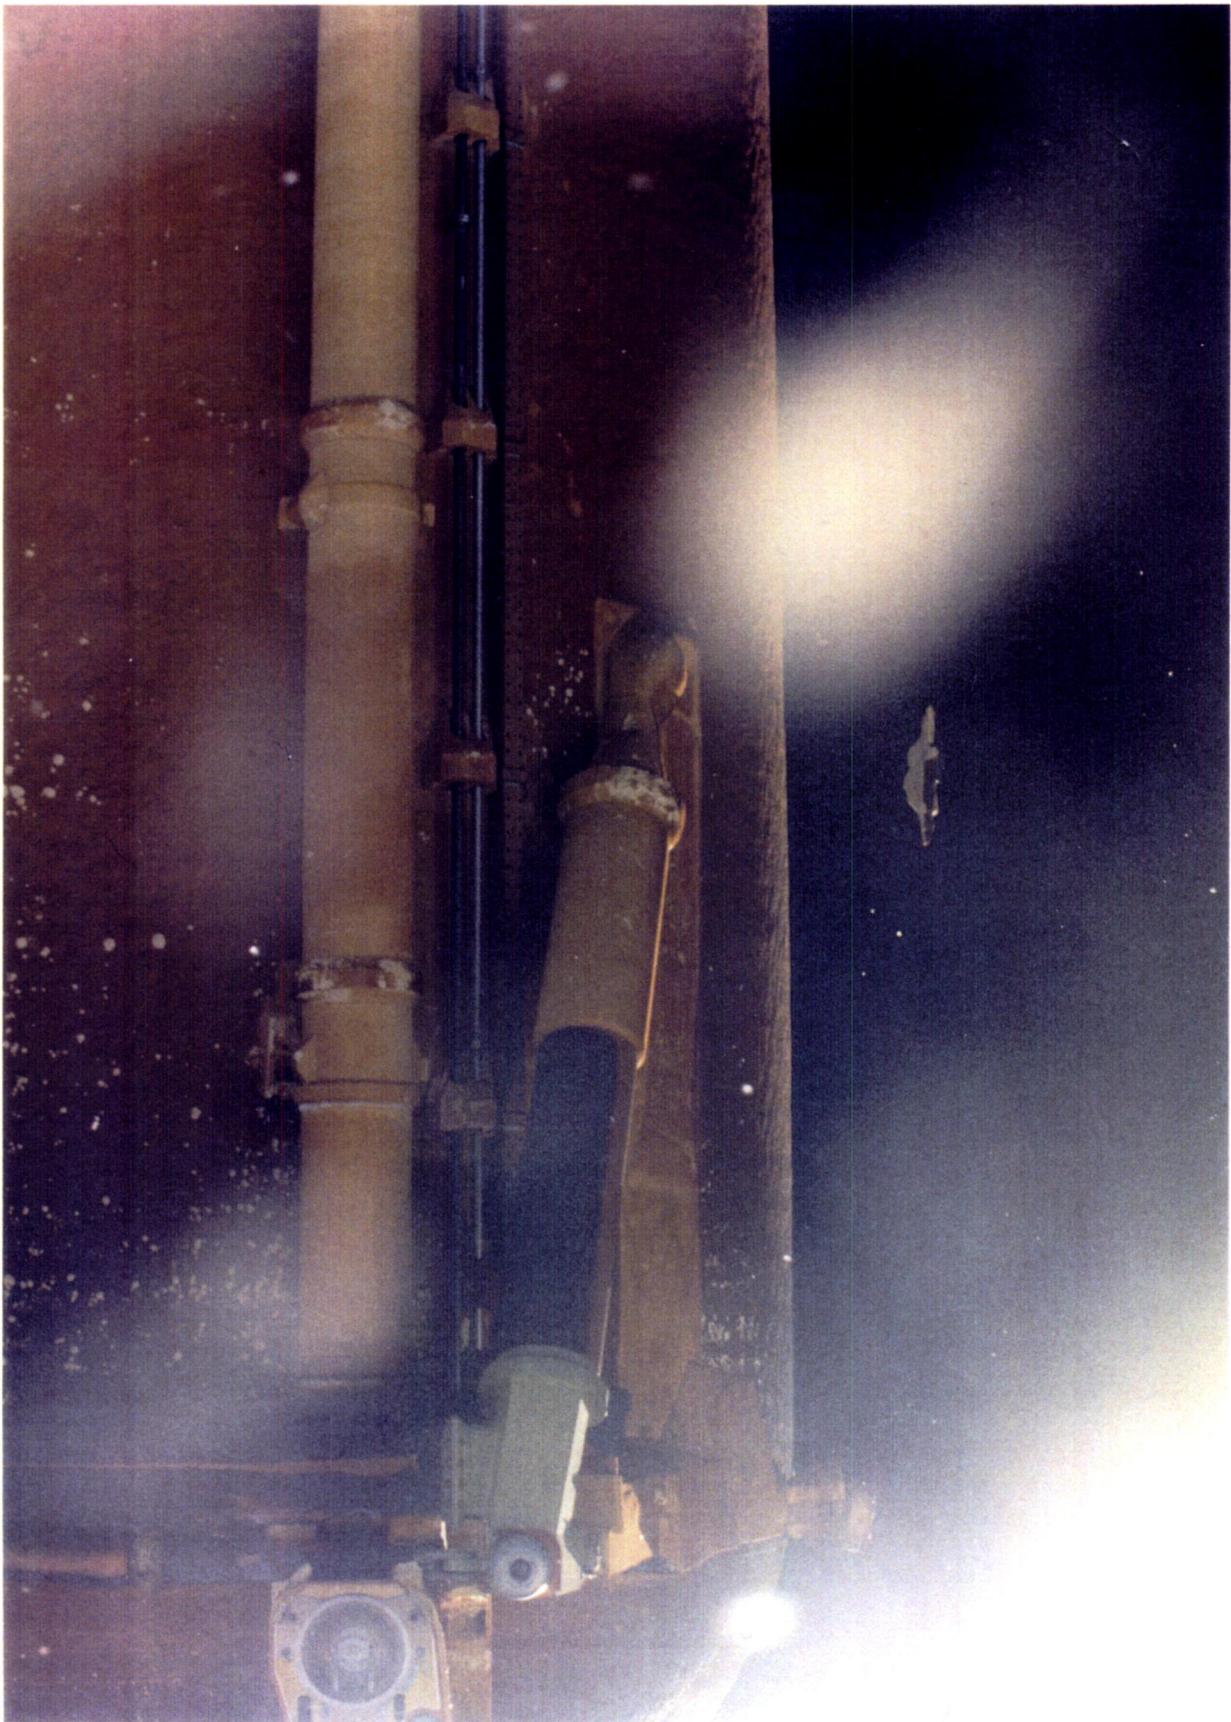
**Photo 18: Small Piece of External Tank Foam**

A small piece of foam insulation drifted by the camera lens shortly after separation of the ET from the Orbiter. Since one side of the foam piece appears charred or blackened, the foam most likely originated from the LO2 ET/ORB umbilical or cable tray area.

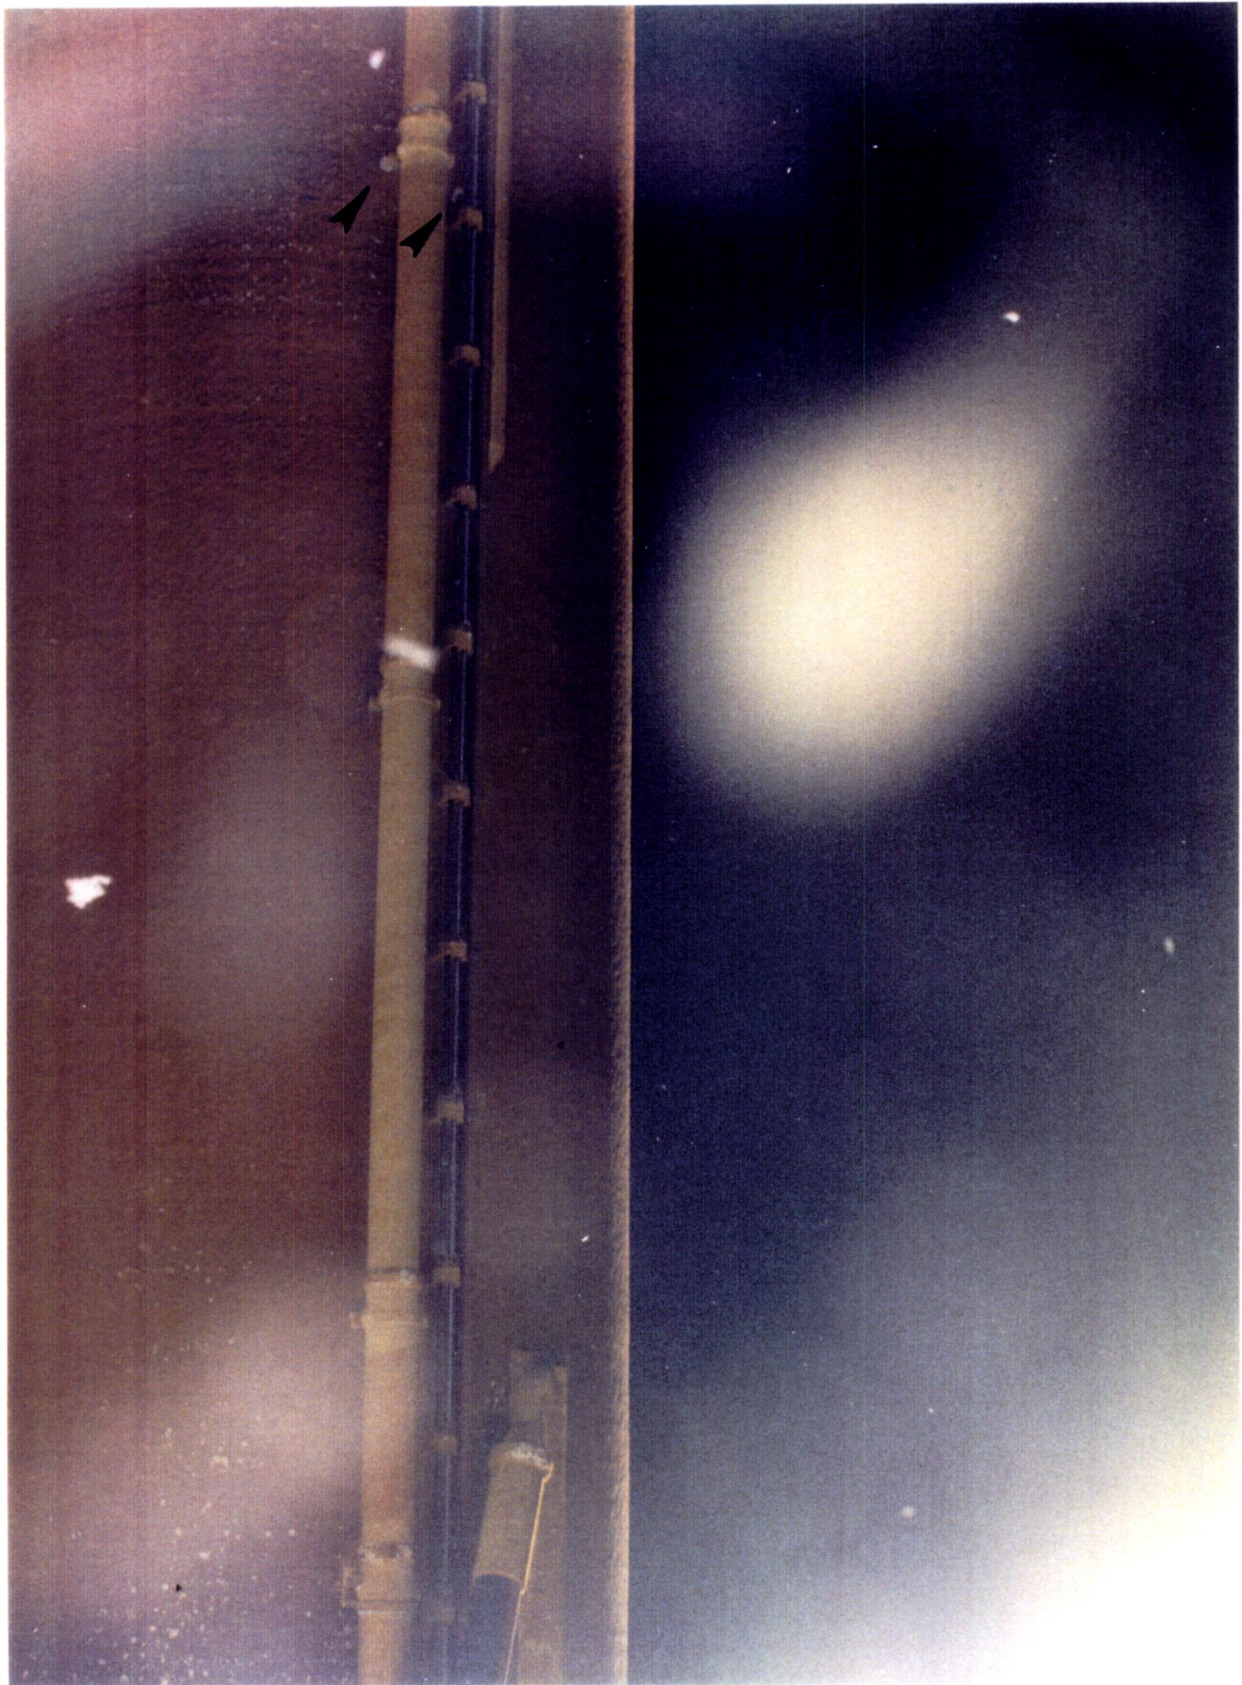
**Photo 19: ET LH2 Tank Acreage Divots**

The LH2 tank acreage was generally in good condition with the exception of one 5-inch diameter divot near the LO2 feedline at station XT-1377 and one 5-inch divot between the LO2 feedline and the pressurization line support at station XT-1377. The divots appeared to expose substrate by showing primer.

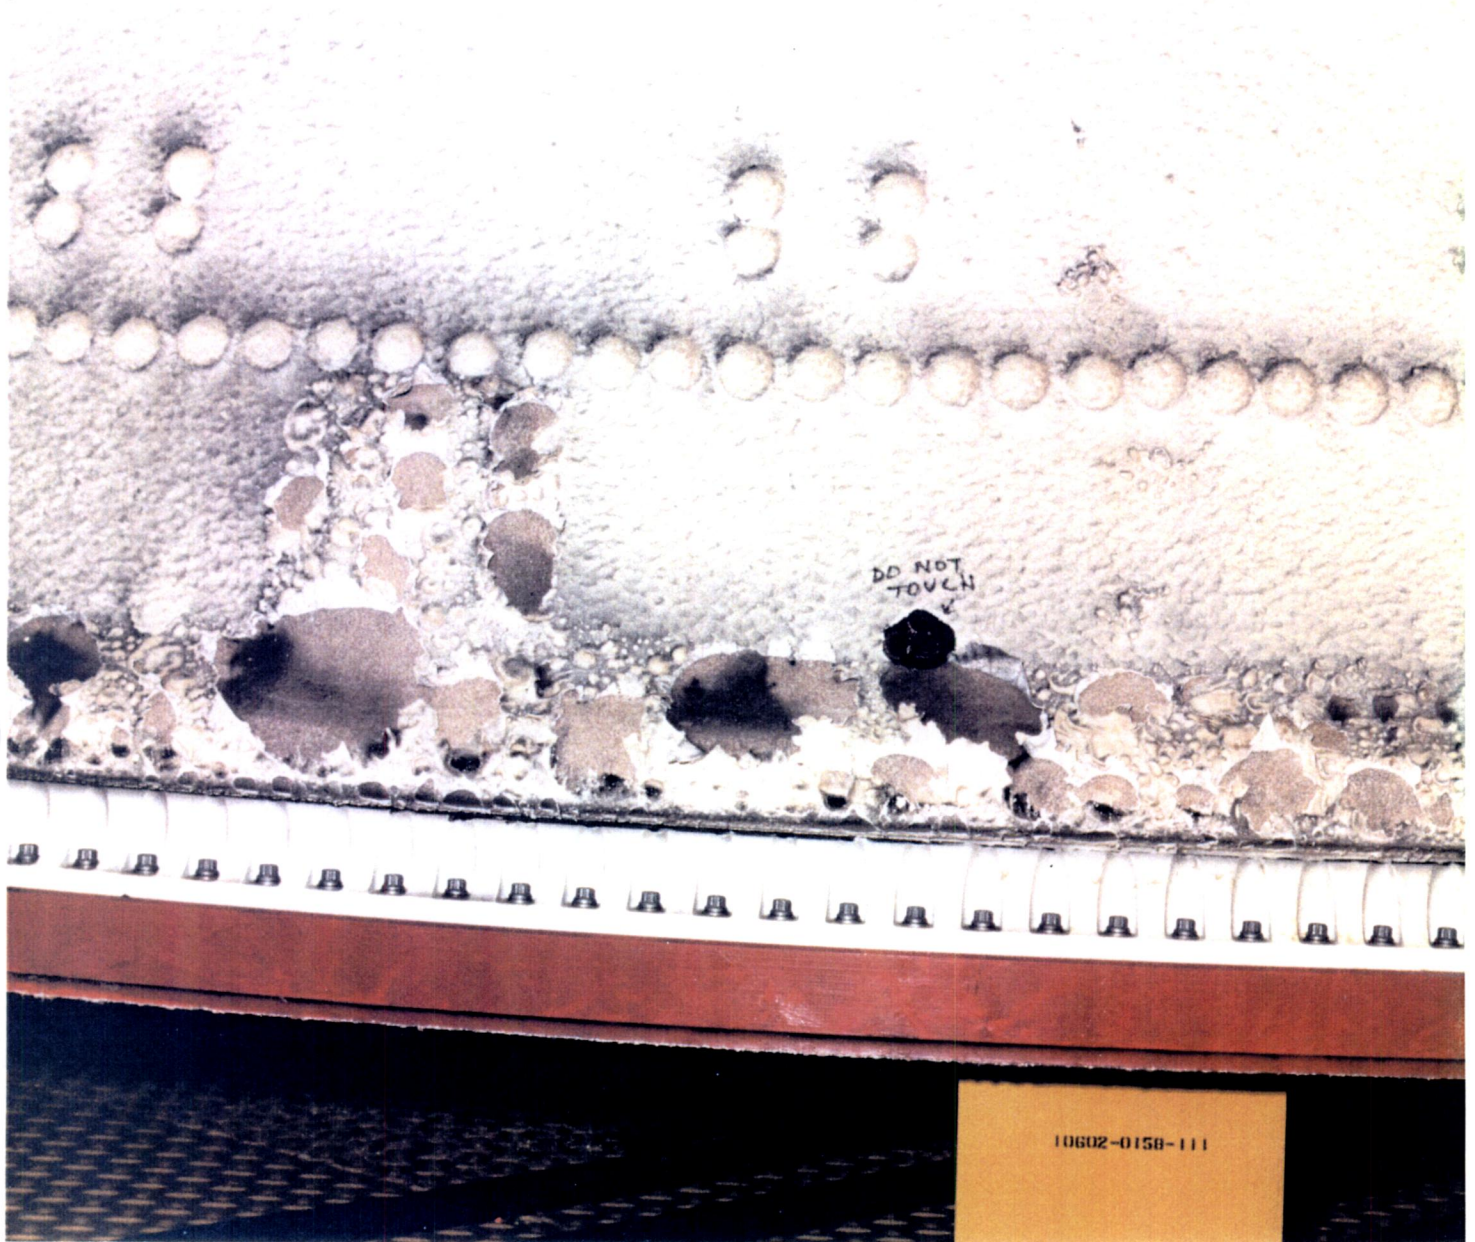
**Photo 23: LH Frustum**

The LH frustum was missing one 2-inch diameter piece of TPS (divot) near the XB-395 ring frame between the +Y/+Z axes. The exposed substrate appeared darkened. Laboratory analysis showed the divot was caused by a debond of the MSA-2 from the PR-1422. The divot occurred after BSM firing (absence of sooting) but sometime during re-entry (heating effects). Hypalon paint was blistered/missing where BTA closeouts had been applied.

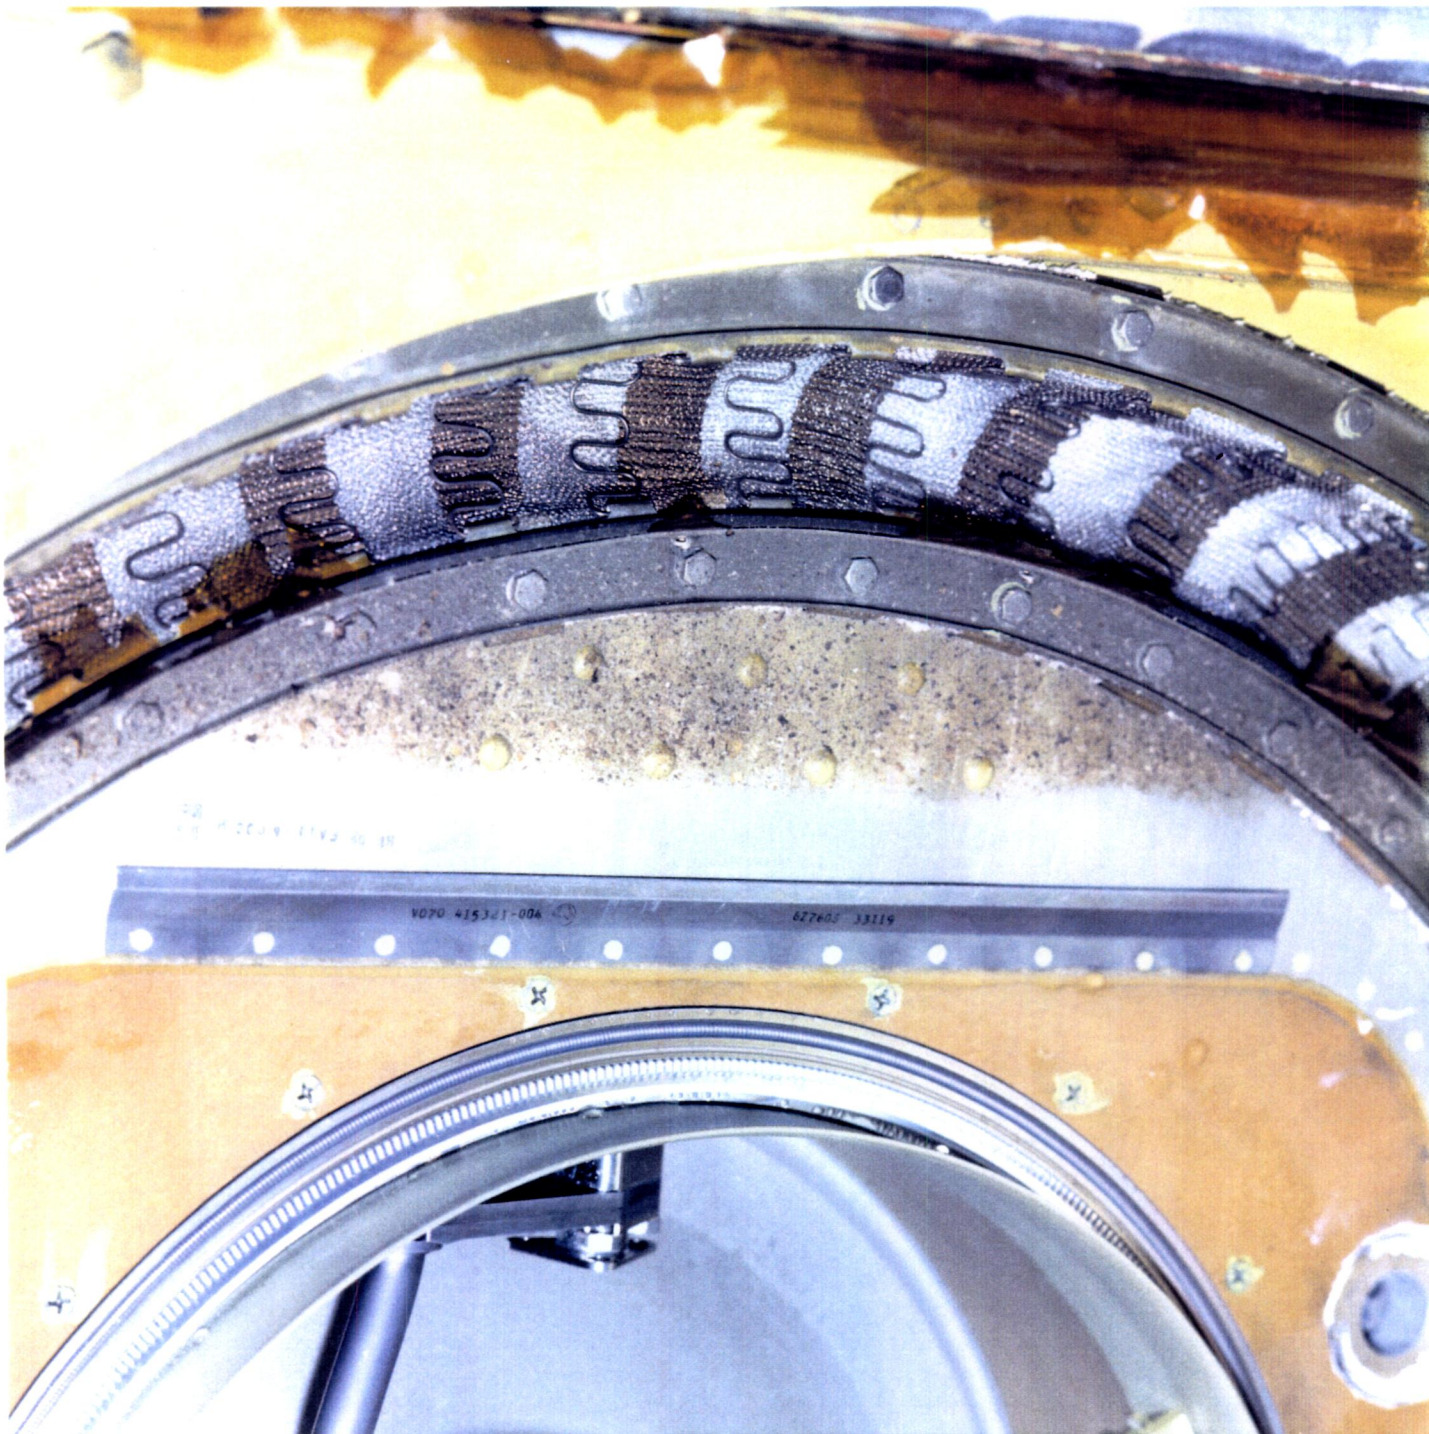
**Photo 29: Debris and Exhaust Residue**

Exhaust residue, small TPS particles, and debris had accumulated on both LH2 and LO2 ET/ORB umbilical plates during ascent

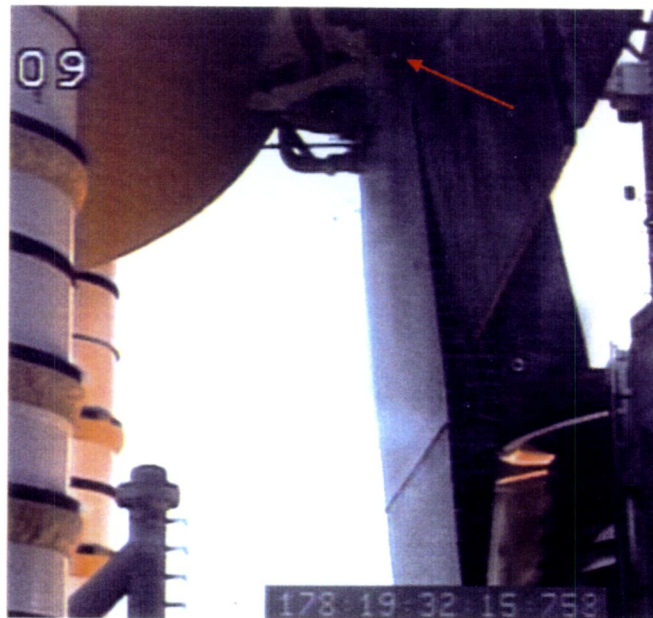
Figure 2.1.1.1 (A) Debris Strike to Umbilical Well Door Sill at T-3.2 seconds MET

Normal ice debris was noted falling from the LH2 and LO2 ET/Orbiter umbilical disconnect areas at SSME ignition through liftoff. A white piece of debris from the ET/Orbiter umbilicals was seen to strike the umbilical well door sill at T-3.2 seconds (Figure 2.1.1.1 A). Three small light colored pieces of debris appeared to travel upwards and strike the LSRB at 0.4 seconds MET (Figure 2.1.1.1 B). A small white piece of debris appeared to strike the ET aft dome near the LO2 ET/Orbiter umbilical at 0.7 seconds MET (Figure 2.1.1.1 C). None of the debris strikes were seen to damage the launch vehicle. No follow-up action was requested.

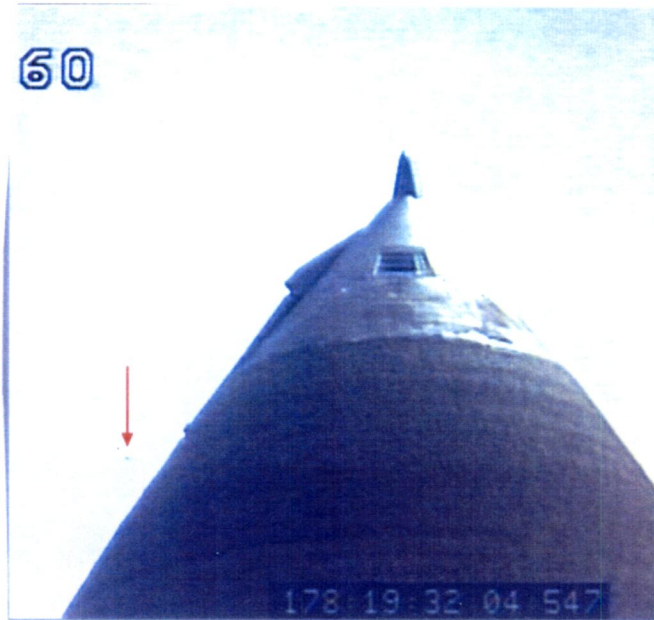
**Figure 2.1.1.2** Debris near Forward Tip of ET

Two small light-colored pieces of debris were seen falling from near the forward tip of the ET at T-14.6 and T-5.8 seconds. The debris was not seen to contact the vehicle. No follow-up action was requested.

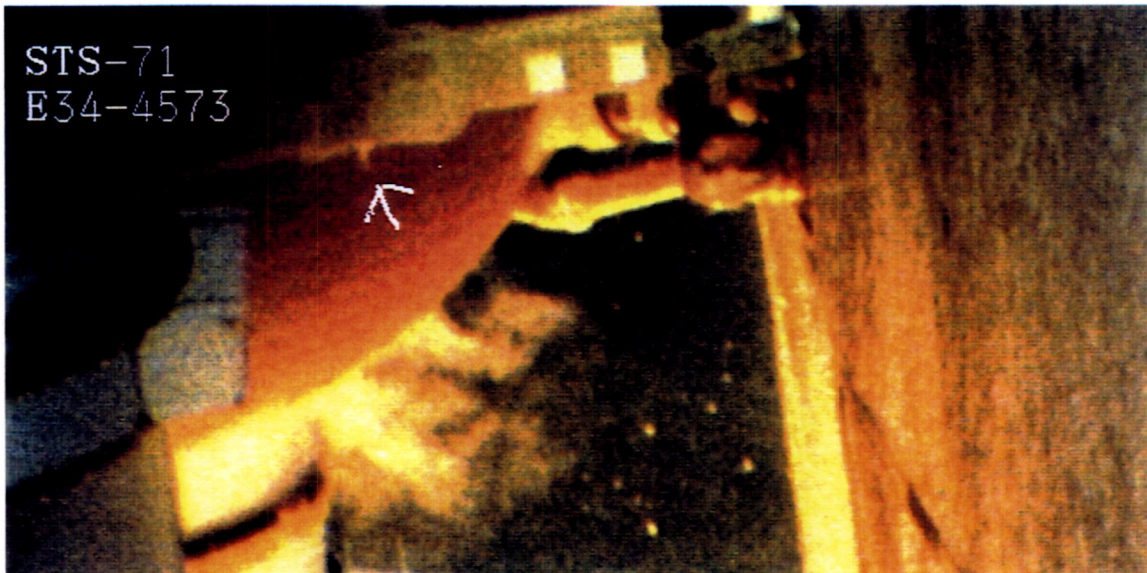
**Figure 2.2.3** Vapors Coming from ET/SRB Strut Cable Tray Drain Hole

Vapors were seen coming from the -Y ET/SRB strut cable tray drain hole at liftoff. KSC reported that this was an expected occurrence due to the humid atmospheric conditions at the time of launch. No follow-up action was requested.

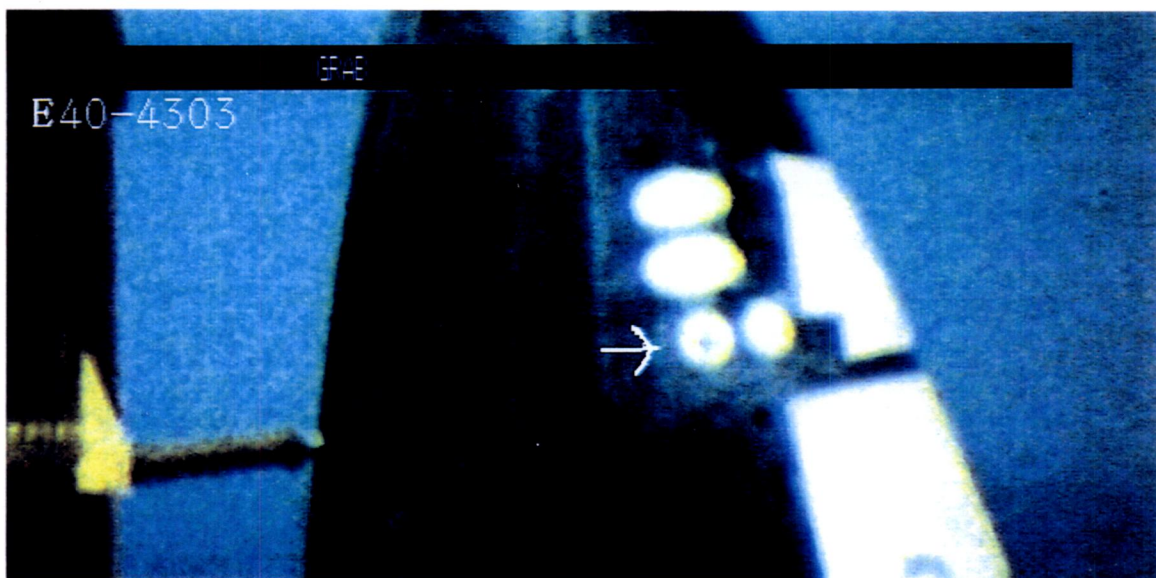
**Figure 2.2.4** RCS Cover Tear on F3L Thruster at Liftoff

An RCS cover (paper) tear was seen on the F3L thruster at liftoff. No follow-up action was requested.

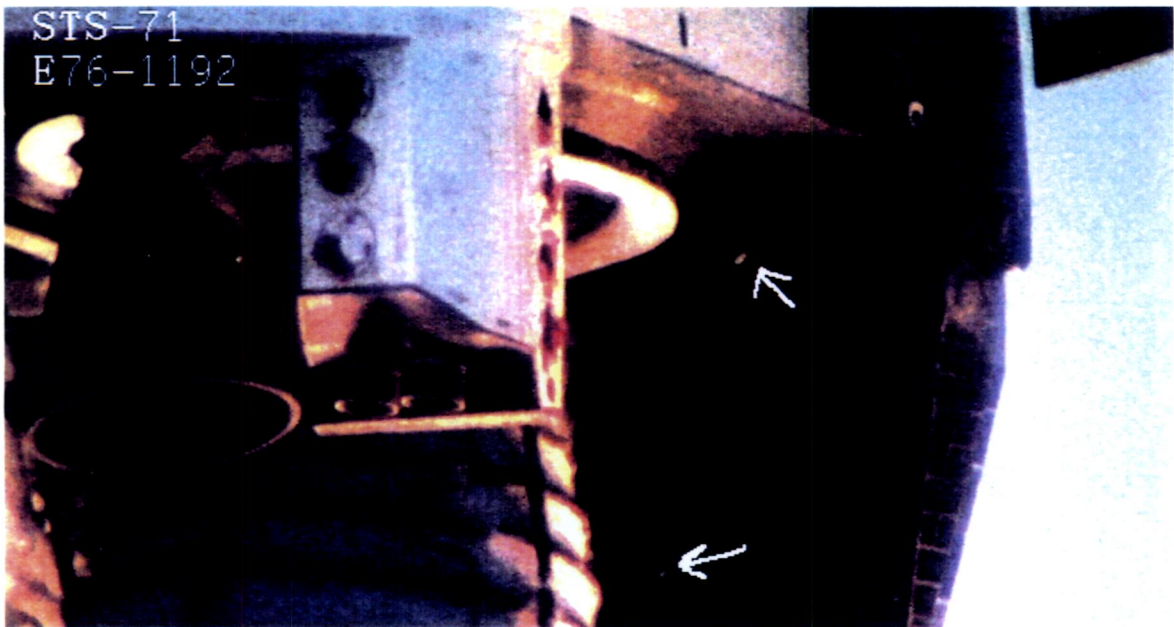
**Figure 2.2.6** Tile Surface Coating Material Missing on +Z Side of Body Flap

KSC reported in their post landing inspection report that numerous tile damage sites on the +Z side of the body flap outboard of SSME #3 corresponded to sites identified in the launch film review and were caused by SSME ignition vibration/acoustics.

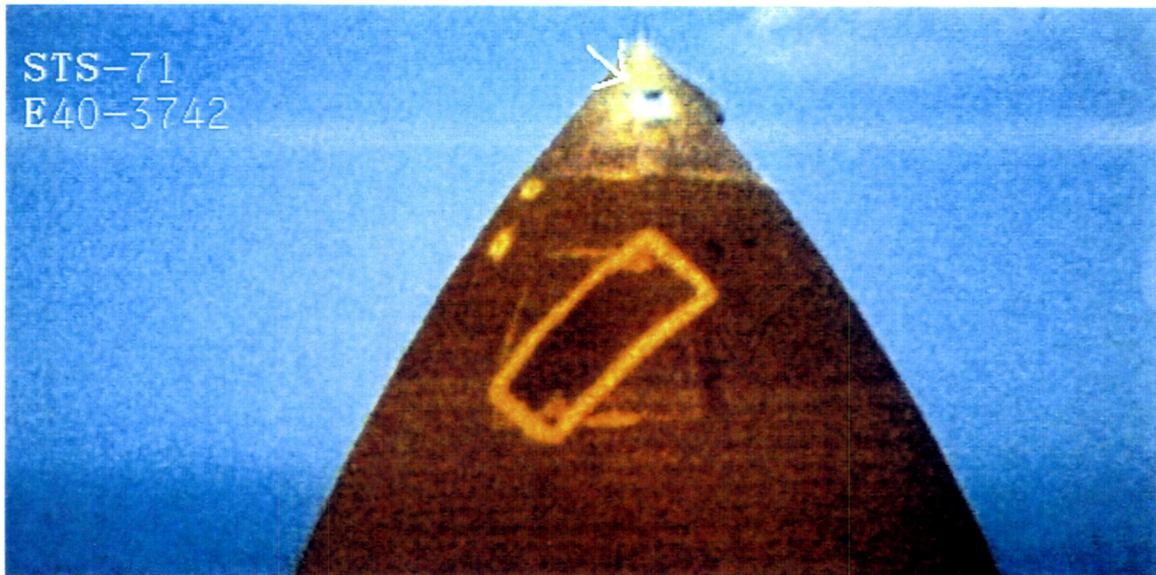
**Figure 2.2.7** Surface Discoloration on ET Nose Cone

Several small areas of surface coating material appeared to be discolored or missing on the ET nose cone at liftoff. KSC reported that topcoat, which had adhered to the GOX vent seal during hood retraction, was missing from several areas of the nose cone footprint area. No follow-up action was requested.

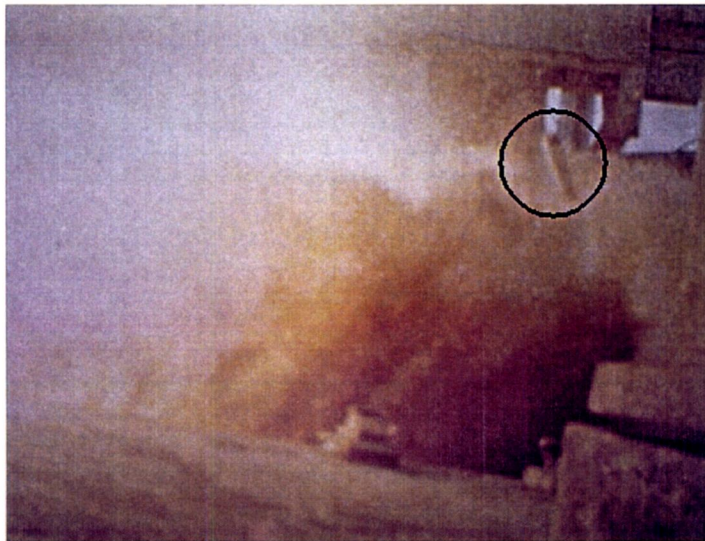
Figure 5 Large debris object from SRB flame duct

A somewhat larger amount of debris than normal was noted from the SRB flame ducts during the ignition of the SRB's and vehicle liftoff. Most of this debris appears to be foam and does not strike the vehicle. One of the larger debris objects is depicted in Figure five taken from camera E-11.

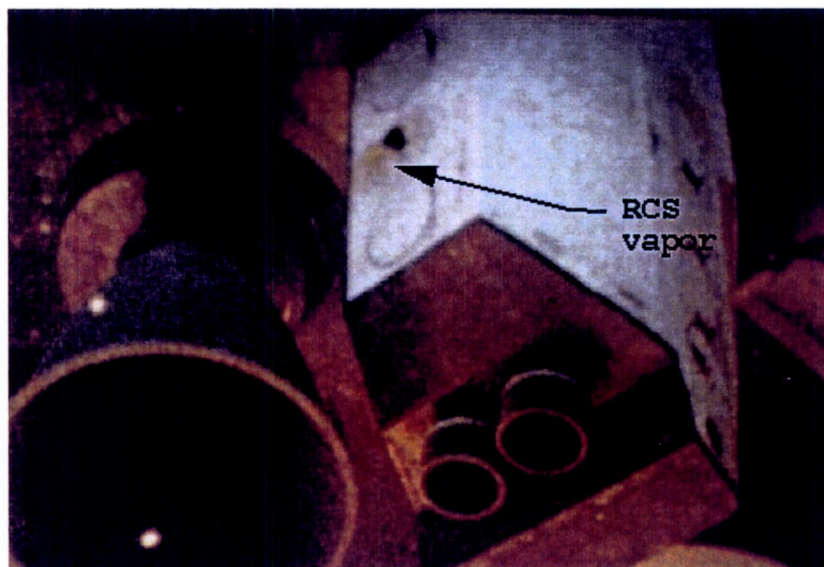
Figure 6 Vapor from RCS motor

During SSME startup the butcher paper that covers the RCS motors is torn by the acoustic waves created by the main engines. It was noted that a brown colored vapor originated from an RCS motor on the right stinger pod when the butcher paper was torn. Figure six depicts this event and is taken from camera E-19.

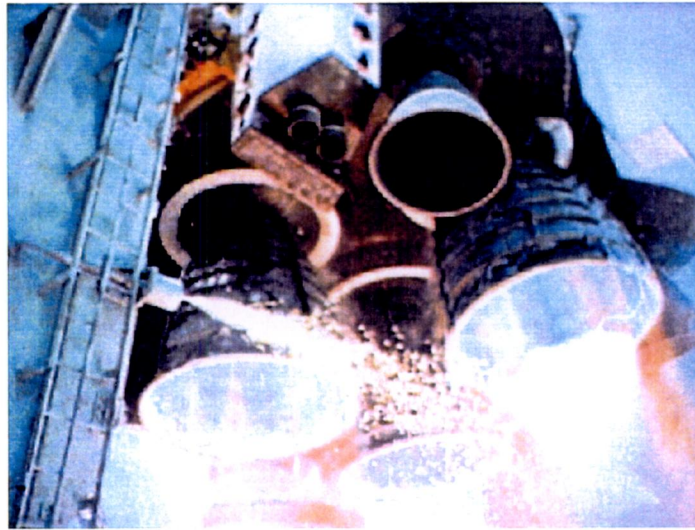
Figure 7 Late mach diamond formation on SSME #2

flew in the number 2 position. Only one other episode of a late mach diamond formation was observed. This occurred on STS-60 on which the mach diamond on ME-2 formed 5 milliseonds later than the mach diamond on ME-3.
